Operating Experience Weekly Summary 97-39

September 19 through September 25, 1997

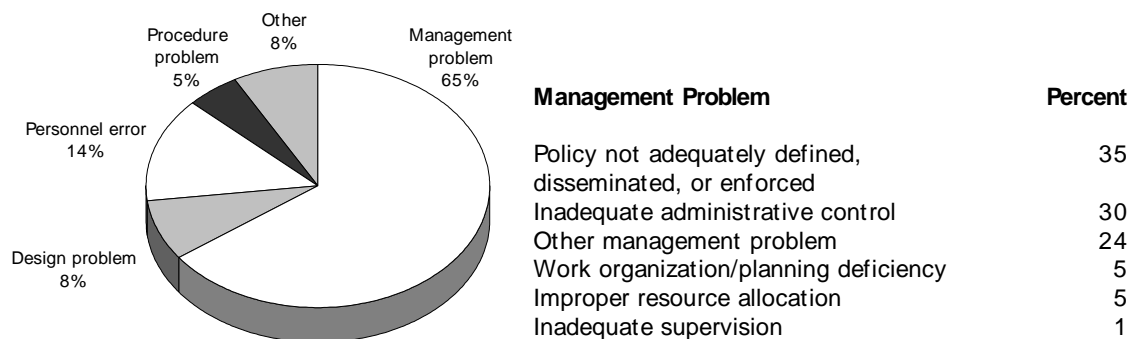
Figure 4-1. Distribution of Root Causes for Safety Analysis Report Discrepancies Resulting in Safety Status Degradation¹

OEAF engineers searched the ORPS database for reports where safety analysis report discrepancies resulted in safety status degradations and found 98 occurrences. Figure 4-1 shows the distribution of root causes reported by facility managers for these events. Management problems represented 65 percent of the root causes. As shown in the figure, policy not adequately defined, disseminated, or enforced accounted for 35 percent of the management problems, with an additional 30 percent attributed to inadequate administrative control.
